# **INDOOR AIR QUALITY ASSESSMENT**

**Massachusetts Department of Transportation  
Merit Rating Board  
25 Newport Avenue Extension  
Quincy, Massachusetts**

Prepared by:  
Massachusetts Department of Public Health  
Bureau of Environmental Health  
Indoor Air Quality Program  
February 2017

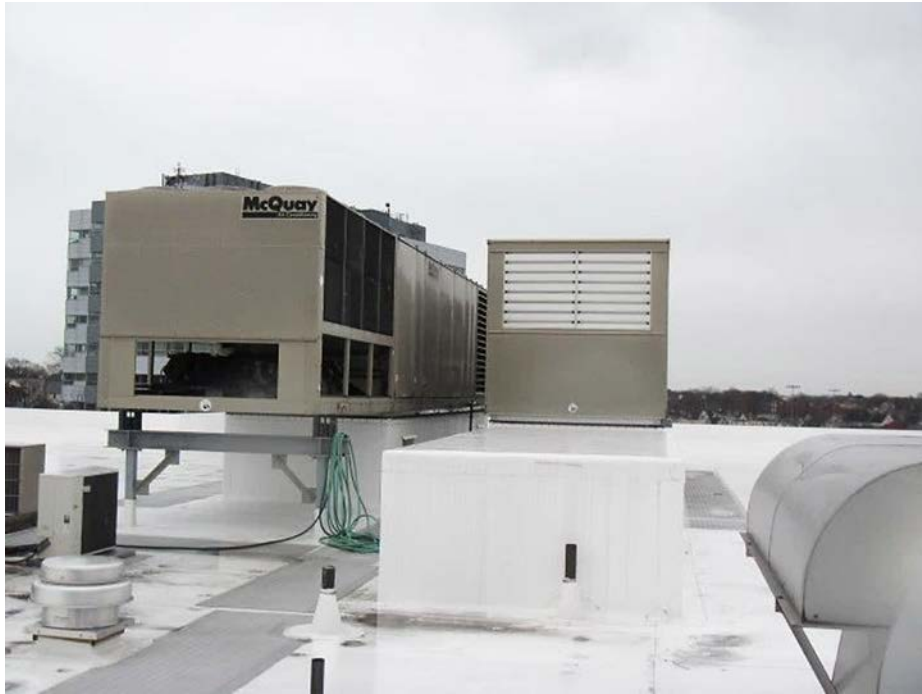
**Picture 1**

Mechanical ventilation is provided by rooftop air-handling units (AHUs, Picture 1). Outside air is drawn through a bank of pleated filters (Picture 2), heated or cooled and delivered to occupied areas via ducted supply diffusers (Pictures 3 and 4). The filters in use at the MRB are a Minimum Efficiency Reporting Value (MERV) of 8, which are adequate in filtering out pollen and mold spores (ASHRAE, 2012). Return air is drawn through grates or around light fixtures (Pictures 5 and 6) and returned back to the AHUs.

**Rooftop air handling units (AHUs)**

11. Have the HVAC system re-balanced, as recommended (every 5 years) in accordance with SMACNA recommendations (SMACNA, 1994).

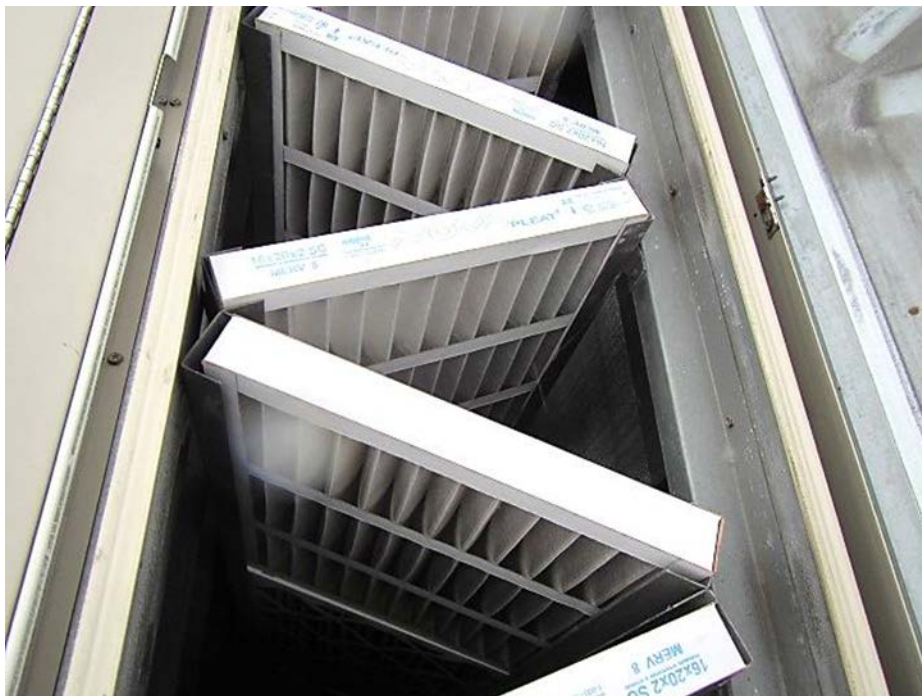
**Picture 2**

**Bank of pleated MERV 8 filters in rooftop AHU**

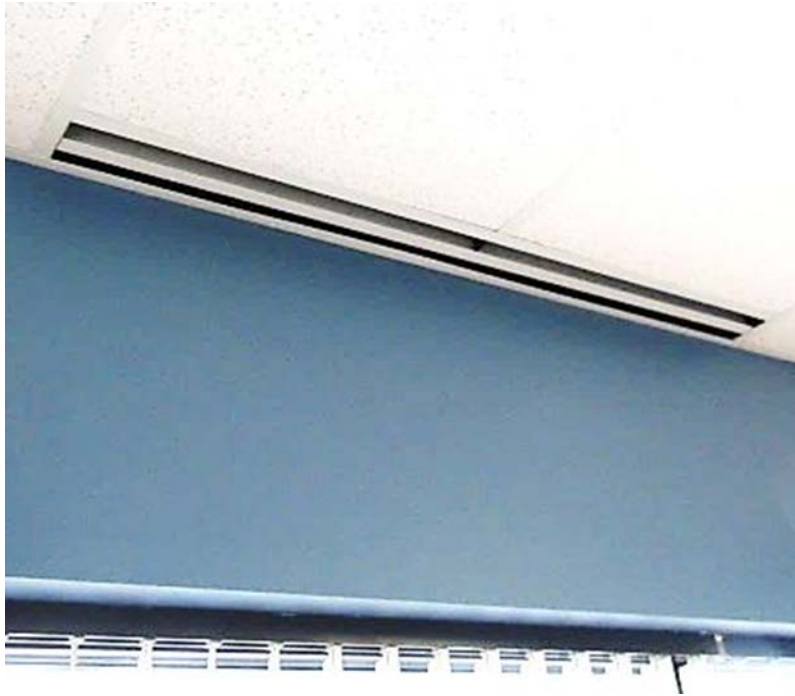
**Picture 3**

**Slotted ceiling diffuser**

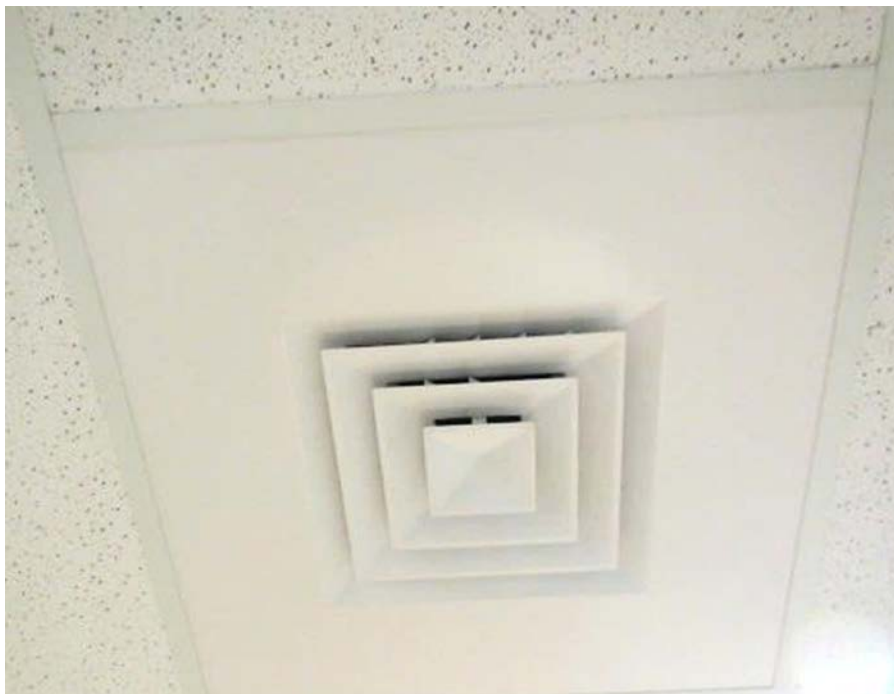
**Picture 4**

**Supply air diffuser**

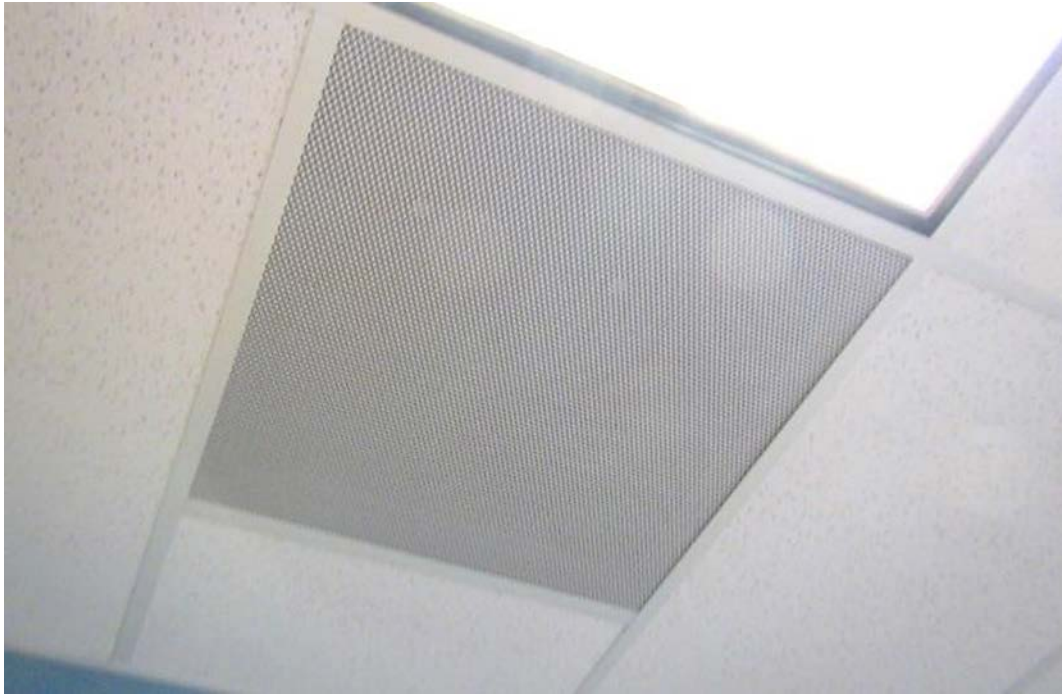
**Picture 5**

**Return grate**

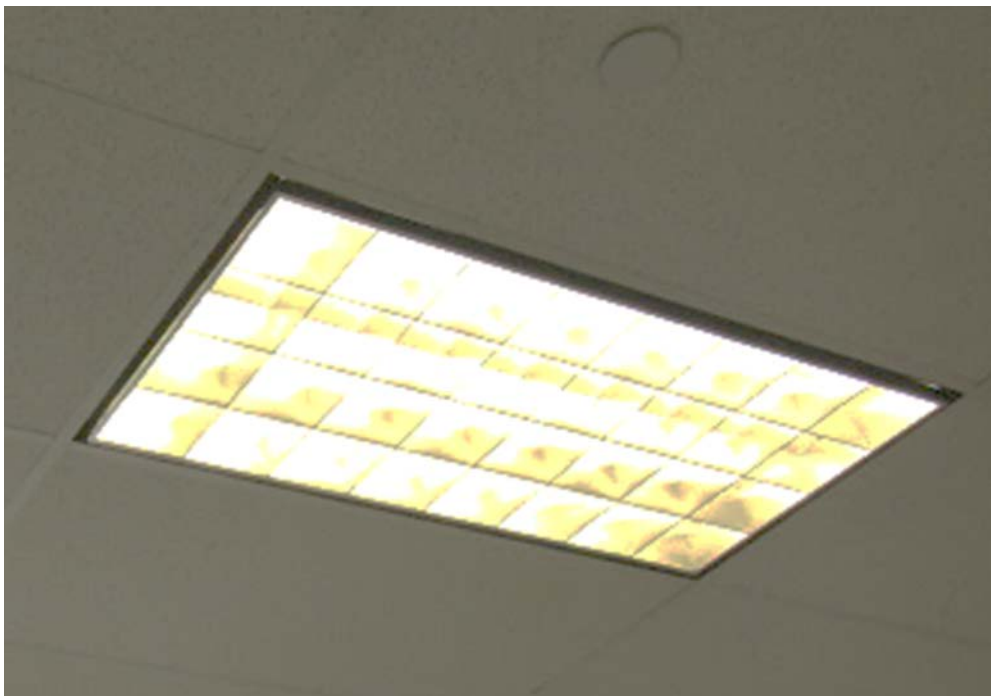
**Picture 6**

**Spaces around light fixtures for return airflow**

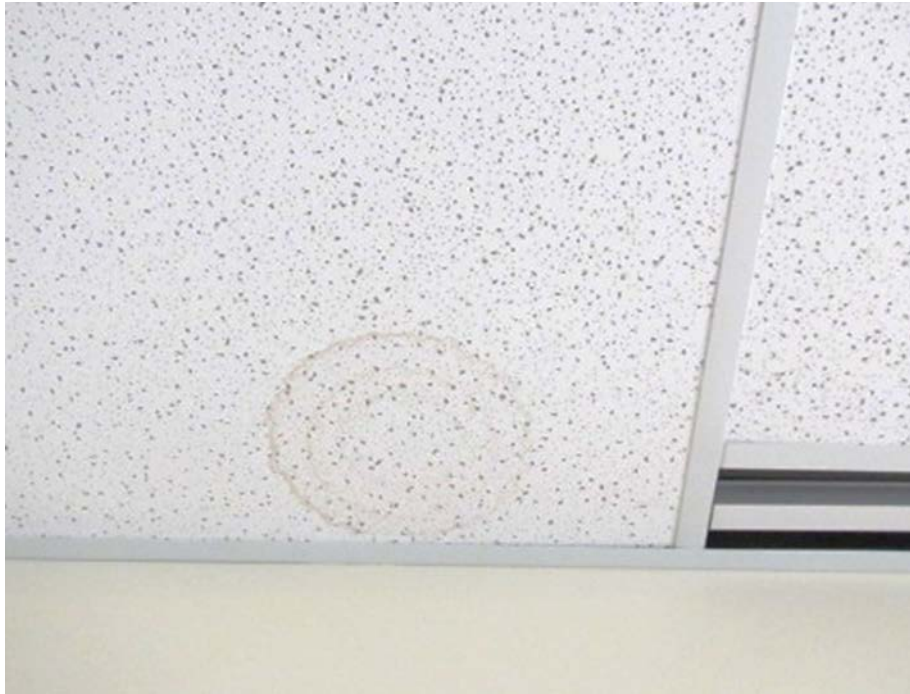
**Picture 7**

No active leaks were observed or reported. A few water-damaged ceiling tiles were observed in area 205, reportedly from an old leak (Picture 7). After the source of the leak above the ceiling tiles is repaired, water-damaged ceiling tiles should be removed and replaced.

**Water-damaged ceiling tile in room 205**

4. Ensure any building envelope or plumbing leaks are repaired and replace water-damaged ceiling tiles.
5. Seal sink countertop/backsplash with caulking in breakroom.

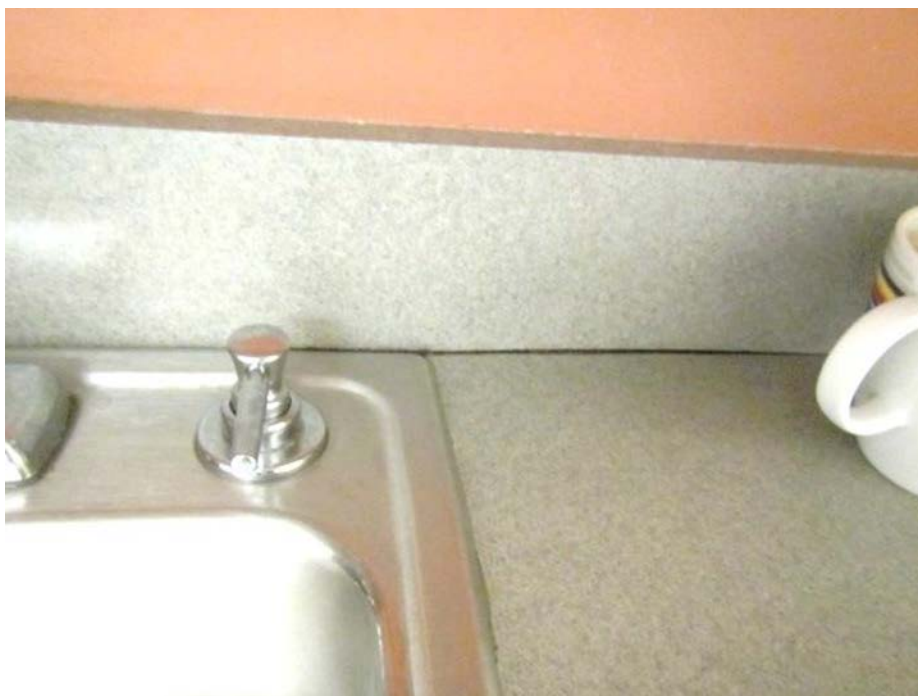
**Picture 8**

The sink in the breakroom had a space between the countertop and backsplash in need of caulking (Picture 8). Chronic moistening of porous building materials can lead to mold growth.

**Space between sink countertop and backsplash**

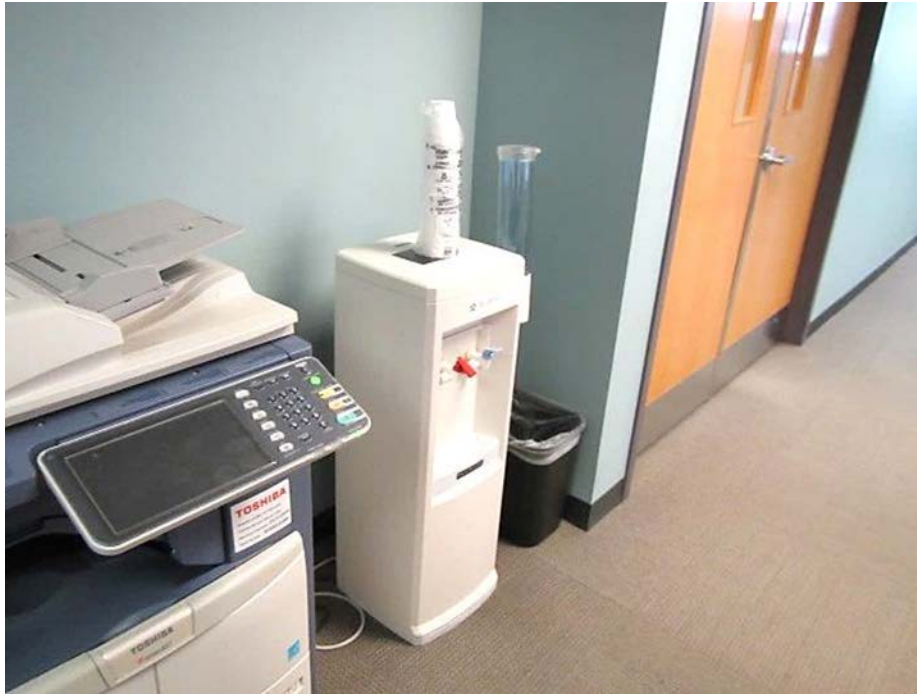
**Picture 9**

Some areas of the MRB had water coolers placed directly on carpeting (Picture 9). Spills or leaks from this equipment can moisten carpet and may cause microbial growth and carpet degradation. Water coolers should be moved to non-carpeted areas or have waterproof trays/mats placed beneath them.

**Water cooler on carpet**

6. Consider placing water dispensers on non-carpeted areas or place a waterproof mat underneath them.
7. Plants should be properly maintained and equipped with drip pans and should be located away from the airstream of air diffusers and portable filter units to prevent the aerosolization of dirt, pollen and mold.

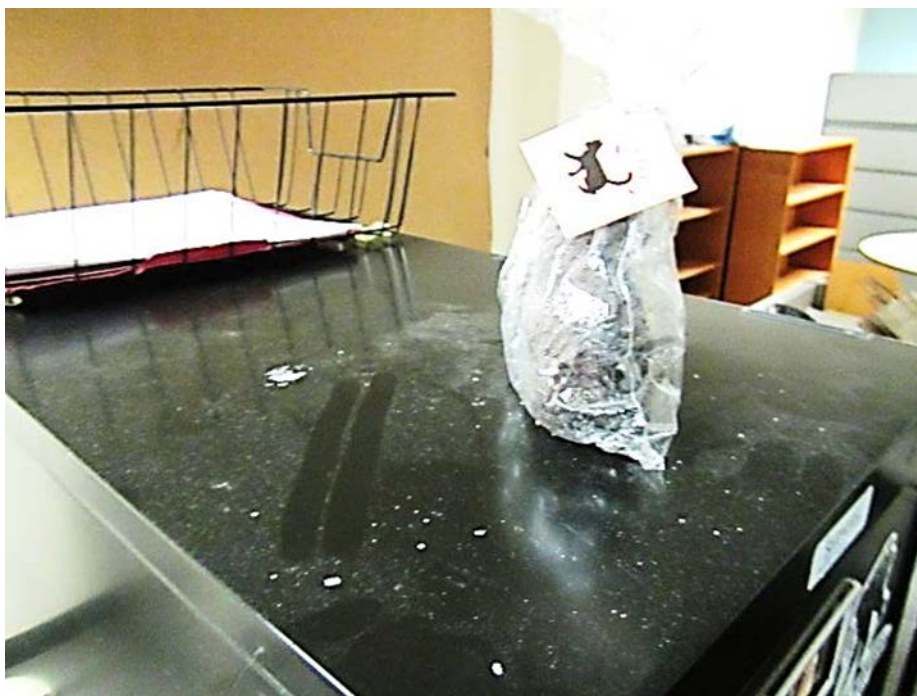
**Picture 10**

Some personal fans, supply and exhaust vents were observed to be dusty (Table 1). Dust can be reaerosolized from these items and they should be cleaned regularly. Dust accumulation was also observed on flat surfaces in some areas (Picture 10).

**Dust accumulation on flat surface**

8. Consider installing exhaust ventilation in photocopier area to prevent the migration of odors and pollutants into occupied spaces.
9. Clean personal fans, supply and return vents periodically of accumulated dust.

10. Relocate or consider reducing the amount of stored materials to allow for more thorough cleaning. Clean items regularly with a wet cloth or sponge to prevent excessive dust build-up.

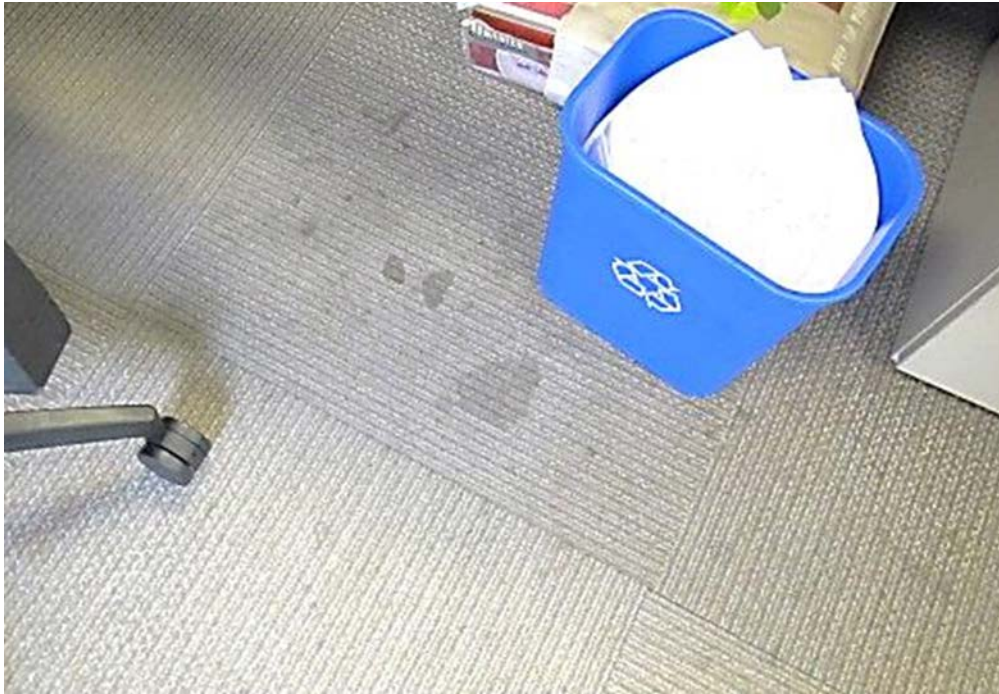
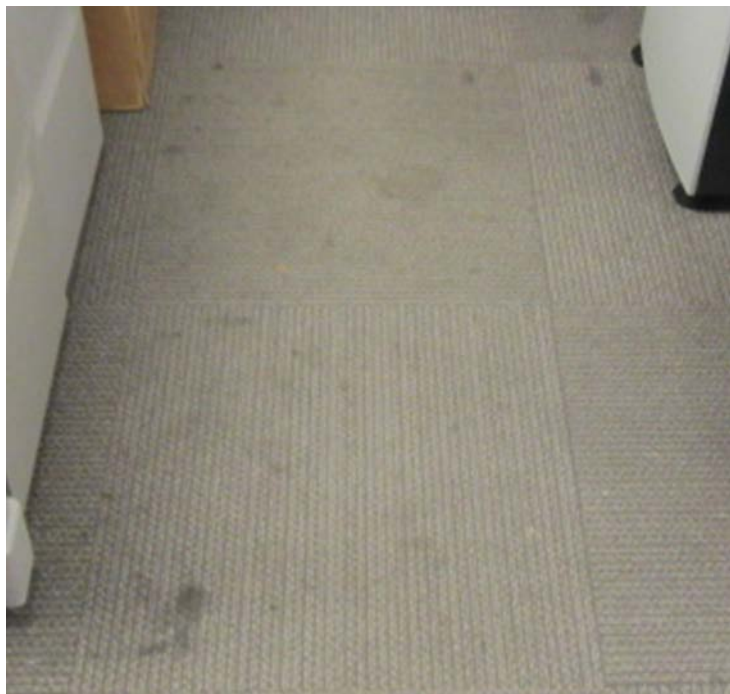
**Picture 11**

Most occupied areas had carpet squares. The Institute of Inspection, Cleaning and Restoration Certification (IICRC), recommends that carpeting be cleaned annually (or semi-annually in soiled high traffic areas) (IICRC, 2012). In many areas, the carpeting appears to be heavily soiled, worn and past its useful life (Table 1, Pictures 11 and 12).

**Soiled carpeting**

12. Clean carpeting annually or semi-annually in soiled high traffic areas as per the recommendations of the Institute of Inspection, Cleaning and Restoration Certification (IICRC, 2012).

13. Replace old, worn/soiled carpeting (over 10 years old).
14. For buildings in New England, periods of low relative humidity during the winter are often unavoidable. Therefore, scrupulous cleaning practices should be adopted to minimize common indoor air contaminants whose irritant effects can be enhanced when the relative humidity is low. To control for dusts, a high efficiency particulate arrestance (HEPA) filter equipped vacuum cleaner in conjunction with wet wiping of all surfaces is recommended. Avoid the use of feather dusters. Drinking water during the day can help ease some symptoms associated with a dry environment (throat and sinus irritations).

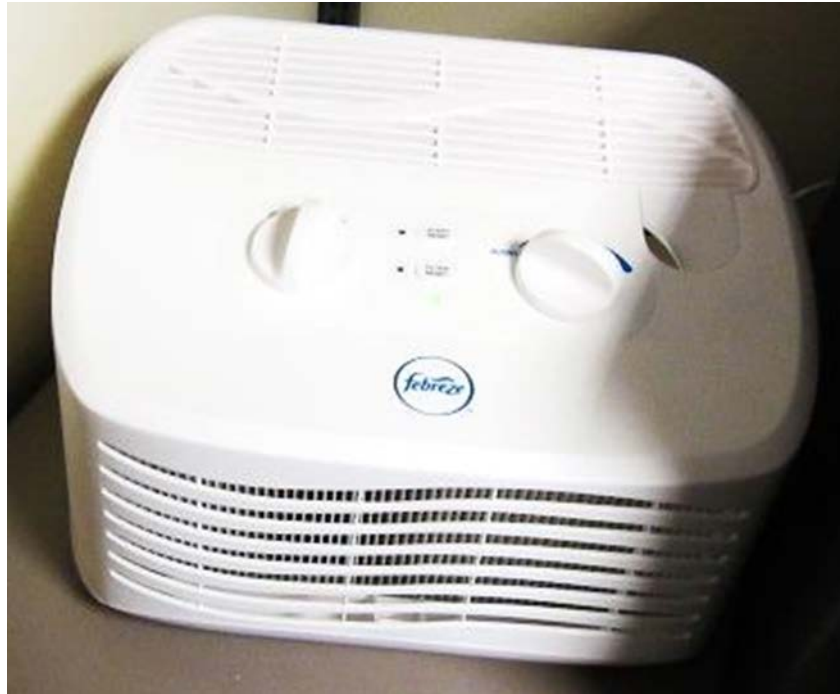
**Picture 13**

instructions. One unit was a combination air cleaner and deodorizer (Picture 13). Air deodorizers can be irritating to sensitive individuals and are not recommended. Many air fresheners contain 1,4-dichlorobenzene, a VOC which can reduce lung function (NIH, 2006). Furthermore, deodorizing agents do not remove materials causing odors, but rather mask odors that may be present in the area.

**Air purifier/deodorizer**

2. Ensure filters for all portable air purifiers are cleaned/changed as per manufactures' instructions.
3. Determine if air purifying unit shown in Picture 13 can be operated without its deodorizer component/cartridge.
